Borton
Lawson

Lititz Public Library
Lititz, PA

I. Executive Summary

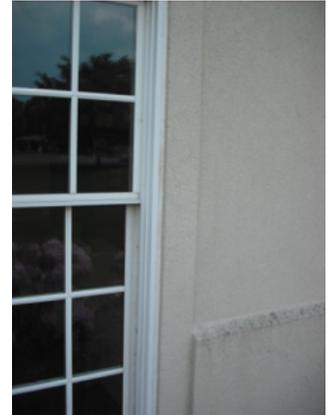
1. Ceiling/Roof:
 - a. The roof is in excellent condition.
2. Walls/Floors:
 - a. Walls and floors are generally in good condition.
 - b. Caulking is used where appropriate.
 - c. The exterior walls are well insulated.
 - d. Near the rear exterior window some cracking of the Dry-Vit is seen possibly due to the structure settling.
3. Windows/Doors:
 - a. The facility has multiple windows; the existing units are energy efficient.
4. Reduce Infiltration:
 - a. Overall there is little accidental loss of air via cracks, uncontrolled openings or building use.
5. Entrance:
 - a. The main entrance has a vestibule system.

- Install "Smart Strip" power strip that can sense when a computer shuts down and in turn shuts down other peripheral devices.
- Inspect exterior Dry-Vit for cracking and make repairs.
- Install occupancy sensors in conference rooms and restrooms.
- Replace exterior incandescent bulbs with CFL units.
- Change or install new fixtures for the flag light fixtures.
- Replace thermostat in the community room to a new multi-day / multi-hour unit. It is recommended that the Honeywell Vision PRO model of unit be used and installed by a qualified contractor.

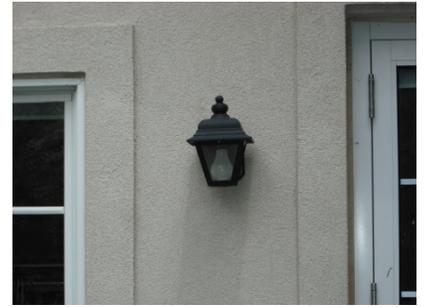
- a. There are 5 exterior incandescent fixtures that can be changed to more efficient CFL fixtures. Typically these lamps cost more but the energy use and the life span of the fixture creates a lower cost of ownership and uses 68% less energy.
- b. The flag pole is lit by two 250W metal halide fixtures. The wattage can be reduced or the fixture changed to a much more efficient fixture.
- c. There are 12 exterior metal halide parking lot fixtures that can be changed to more efficient fixtures. The cost benefit of induction lighting should be reviewed. Typically these lamps cost more but the energy use and the life span of the fixture creates a lower cost of ownership.

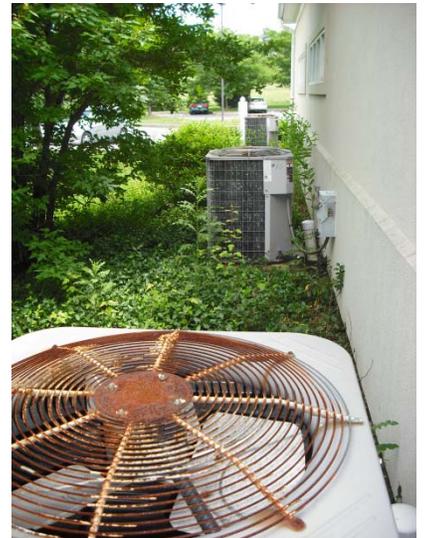
- a. The local thermostats are set for 74 degrees. Care should be taken to make sure that they remain set at this level and that minimal conditioned air is produced when the library is closed. Lockable covers should be installed on thermostats if customers or employees regularly change settings.
- b. The 11 exterior air conditioning units have a SEER of 12. These units are efficient to today's standards and there is no financial justification to change these units.
- c. The thermostat in the community room should be upgraded to a 5/7 day thermostat with multiple time settings.
- d. Heating is provided by natural gas and the units used are energy efficient.
