Warwick Administrative Offices
Lititz, PA

I. Executive Summary

Attached is a summary of Borton-Lawson's findings from a Tier 1 Energy Audit performed on June 2, 2009. The audit team consisted of Bill McFarland P.E. who performed the site visit and Pat Walko, P.E. who assisted in evaluating the mechanical systems.

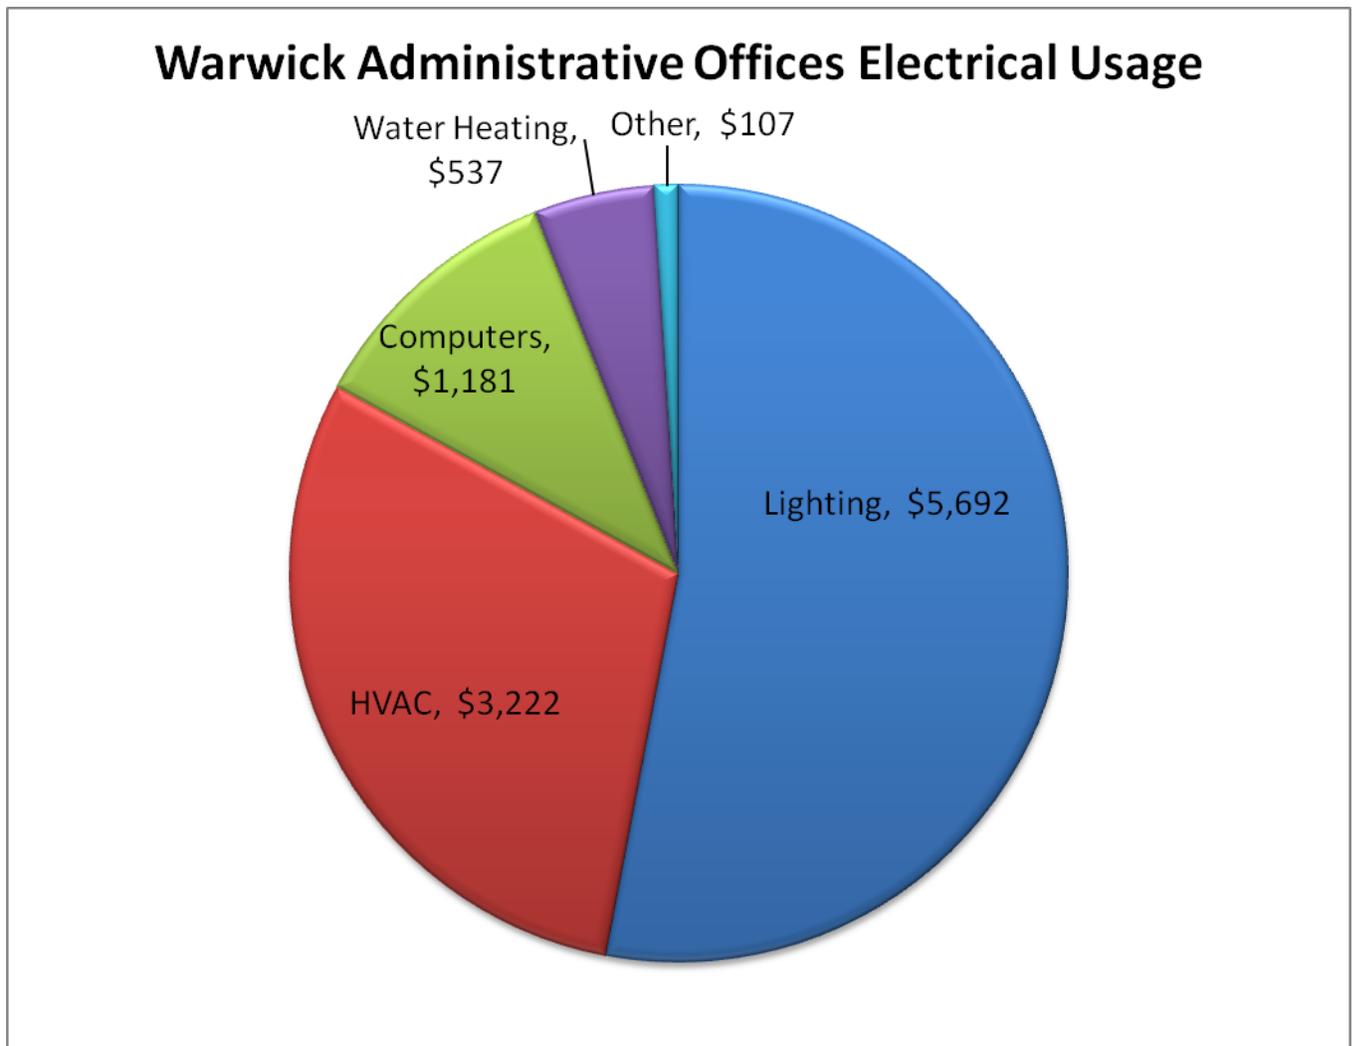
Below is a breakdown of the current electrical usage at the site.

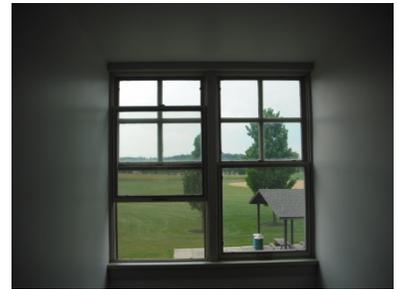
1. Ceiling/Roof:
 - a. The roof is in excellent condition.
2. Walls/Floors:
 - a. Walls and floors are generally in good condition.
 - b. Caulking is used where appropriate.
 - c. The exterior walls are well insulated.
3. Windows/Doors:
 - a. The facility's windows are not the typical double paned unit but a cover over the permanent single pane. There is little data on the effectiveness of these types of units as compared to full double paned windows. These units should be considered for upgrade if the funds are available.
4. Reduce Infiltration:
 - a. Overall there is little accidental loss of air except for the windows.
5. Entrance:
 - a. The main entrance has a vestibule system.

- Evaluate windows and consider moving to double paned units.
- Verify that the site meets current OSHA, NFPA 70E or NEC code for arc flash protection. *
- The site appears to be conducive to having photovoltaic system installed on the roof. This could be augmented with a solar hot water heating application.*

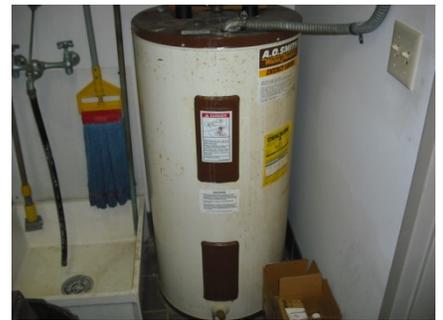
1. Fixtures/Faucets
 - a. Consider changing the fixtures to low flow motion detection in order to best conserve water.
2. Efficiency of the System
 - a. The A.O Smith unit is past its prime and should be changed when funds are available.
 - b. Consider putting the hot water heater on a timer so that the unit does not expend energy off hours.

- Replace T12 fixtures with energy efficient T8 fixtures, saving approximately \$300 annually.
- Install occupancy sensors in any areas intermittently occupied.
- Replace hot water heater with energy efficient unit savings approximately \$80 annually.
- Install a timer on the hot water heater and the water cooler.
- Verify each element in the boiler is operating properly as a 5% variation in output will not meet the buildings needs. A boiler upgrade to an Energy Star unit would save approximately \$195 annually is not economically justified due to an approximate installation cost of \$5,000 (payback of over 25 years).
