Lititz Run - Banta Site

PROJECT TYPE
 Stream and Floodplain Restoration

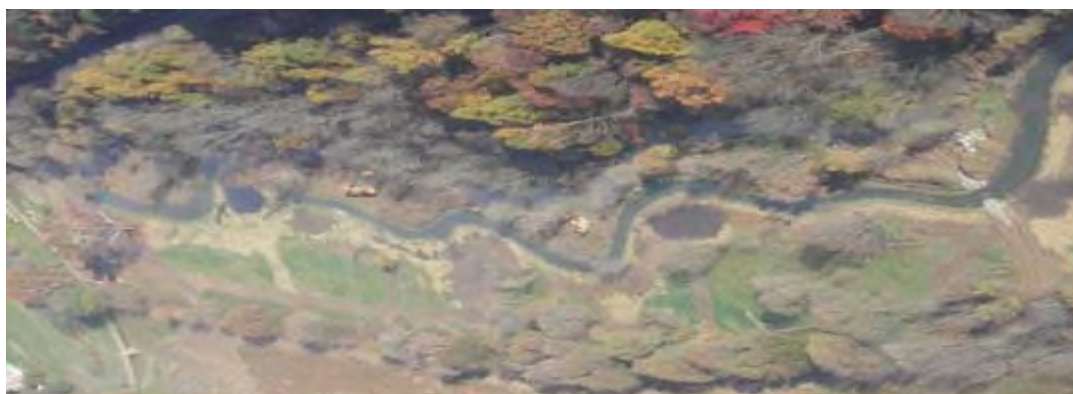
BEFORE

PROBLEM
 This section of Lititz Run, just upstream of an old mill, was highly degraded. The channel was highly incised, with the streambed too far below the floodplain, and the entire stream and floodplain system was perched on layers of legacy sediments. The unstable stream was threatening a nearby local road.

SOLUTION
 The stream channel was relocated to the natural low point of the valley and reconnected to the floodplain. Wetland pockets were created, providing groundwater recharge. The restored floodplain is the home of a thriving native plant and wildlife community.

AFTER
