Lititz recCenter  
*Lititz, PA*

## I. Executive Summary

Attached is a summary of Borton-Lawson’s findings from a Tier 1 Energy Audit performed on June 2, 2009. The audit team consisted of Bill McFarland P.E. who performed the site visit and Pat Walko, P.E. who assisted in evaluating the mechanical systems.

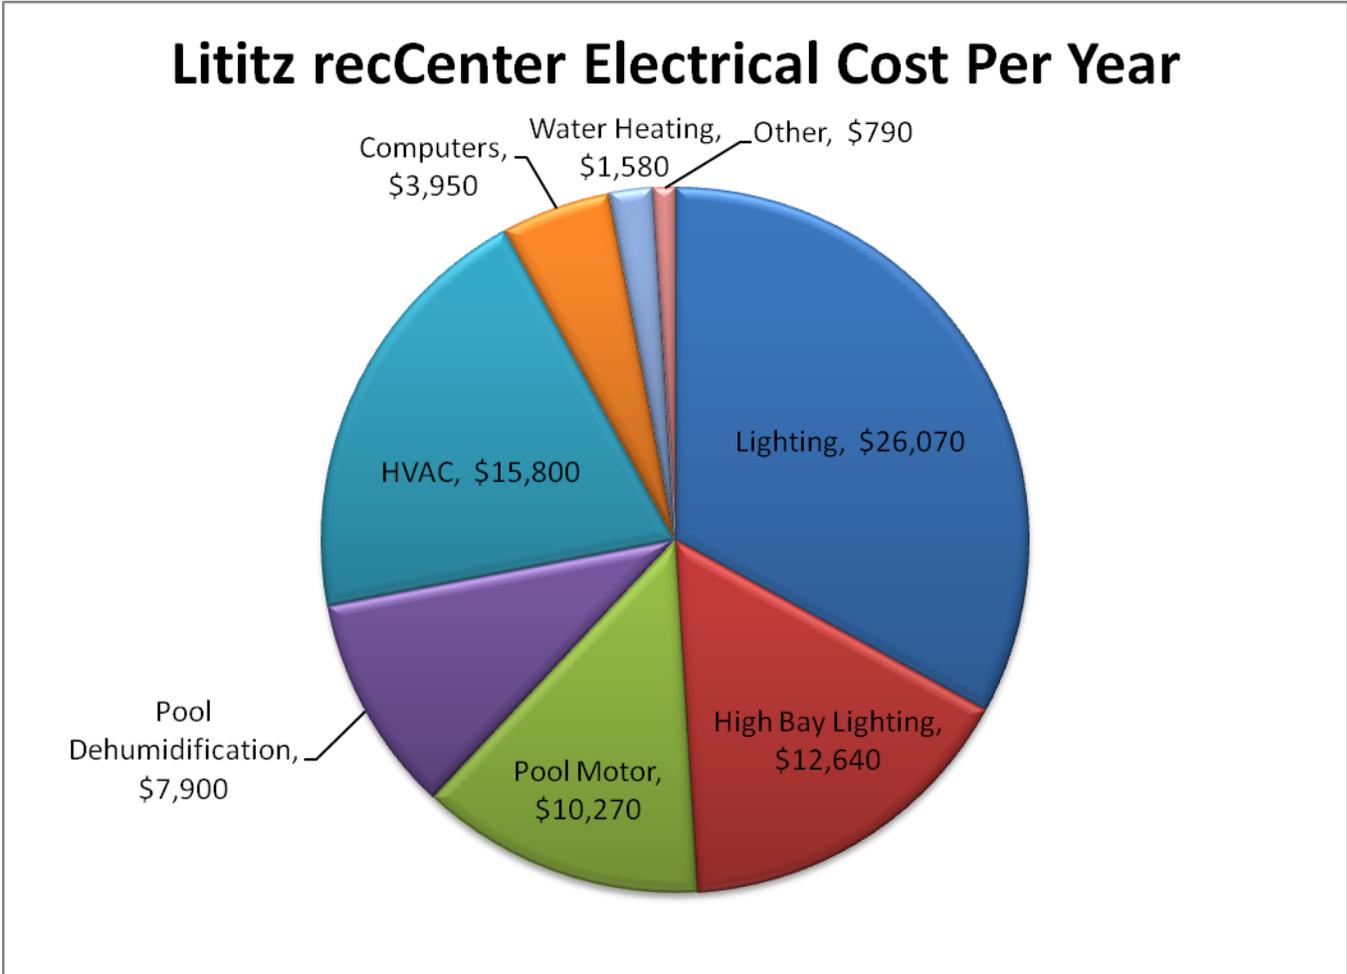
Below is a breakdown of the current electrical usage at the site.

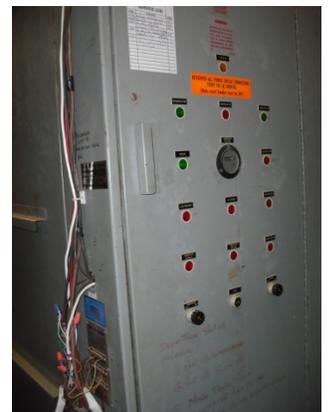
1. The Dry-O-Tron Dehumidifier has an approximate SEER of over 10 meaning that is not a candidate for an energy efficiency upgrade however, the age of the unit
2. A thermal pool blanket should be used as it will retain and reduce evaporation by 90% during unoccupied periods. This could save up to \$1,750 annually.
3. A night setback thermostat and outdoor air shutoff during unoccupied periods will cut room heating and ventilation requirements by 20% during unoccupied periods. This could save up to \$1,580 annually.
4. The existing 20HP motor for water circulation should be changed to a NEMA Premium Motor. This would save approximately 2% on the annual electrical usage which totals \$10,400 or \$210 annually.
5. The standard chlorine system is currently augmented with an efficient UV system.

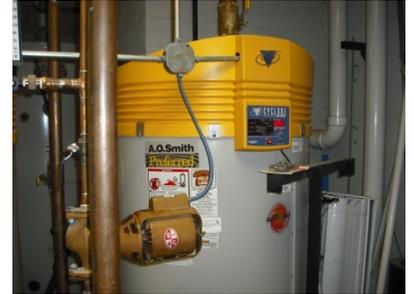
1. Fixtures/Faucets
  - a. Consider changing the fixtures to low flow motion detection in order to best conserve water.
2. Efficiency of the System
  - a. The A.O Smith units are energy efficient and do not need to be changed at this time.
