Lititz Run - Hurst/Wenger Property Stream Corridor and Floodplain Restoration

Warwick Township, Lancaster County, Pa.

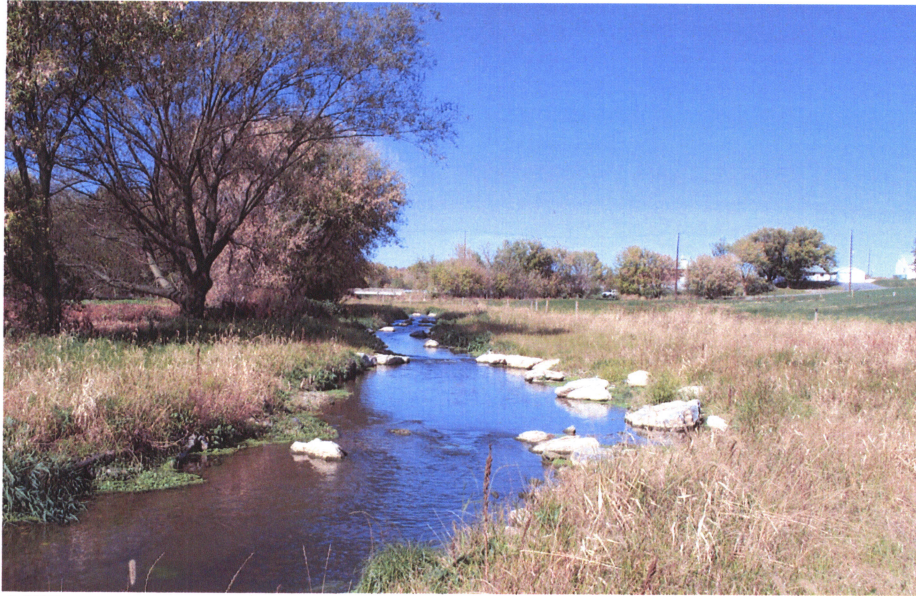
AFTER

This section of Lititz Run, adjacent to the Warwick Township Riparian Park, was overly wide and shallow, the channel was full of sediment, and aquatic habitat had been degraded. LandStudies designed and created a project to restore 900 linear feet of stream corridor, which included relocating a 140-foot section of channel to the lowest part of the valley floor. The floodplain along the left bank was cut down to reattach it to the stream channel. Soils removed from the left bank were used to create, adjacent to the active channel, benches 12 to 18 inches above the baseflow elevation. The finished project, which included the planting of native woody and herbaceous wetland plants, resulted in the creation of new wetlands, the reduction of erosion and sedimentation within the channel itself, and the increased stability of this section of Lititz Run.
