# Warwick Township Santo Domingo Creek at Route 501 Floodplain Restoration Project

Spring 2024

## Restoration Near Rock Lititz

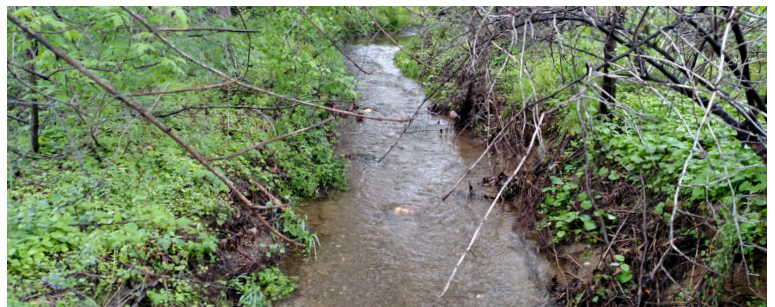
Existing Site Conditions

Warwick Township is collaborating with landowners along a portion of the Santo Domingo Creek to restore approximately 2,350 linear feet of floodplain along a severely eroded and unstable portion of the Santo Domingo Creek. This project anticipates reducing sediment discharge into the Santo Domingo Creek Watershed by over 1 million pounds per year. This project will connect to the existing Rock Lititz Floodplain Restoration project that extends over 3,130 linear feet of the Santo Domingo Creek habitat. Combined, these areas will provide over a mile of restored channel and floodplain, and more than 25 acres of wetlands and riparian buffer.

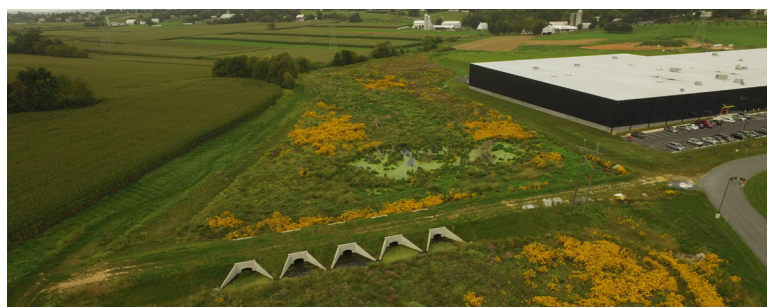
Restored Floodplain - Example

Floodplain restoration is a holistic approach that attempts to address present-day impairments and reestablish a functional floodplain-wetland system that had historically existed on site. Floodplain restoration practices include legacy sediment removal and native vegetation establishment, which provide increased floodplain capacity and establish expansive floodplain-wetland systems that provide significant water quality benefits.
